Re: Rim Columbus Inspection Report Response (M/037/0006)

**ATTACHMENT A
UPDATED FIGURES**

**ATTACHMENT B
PHOTOGRAPHIC DOCUMENTATION**

Denison Mines (USA) Corp.
Rim/Columbus Photographic Log
October 27, 2008

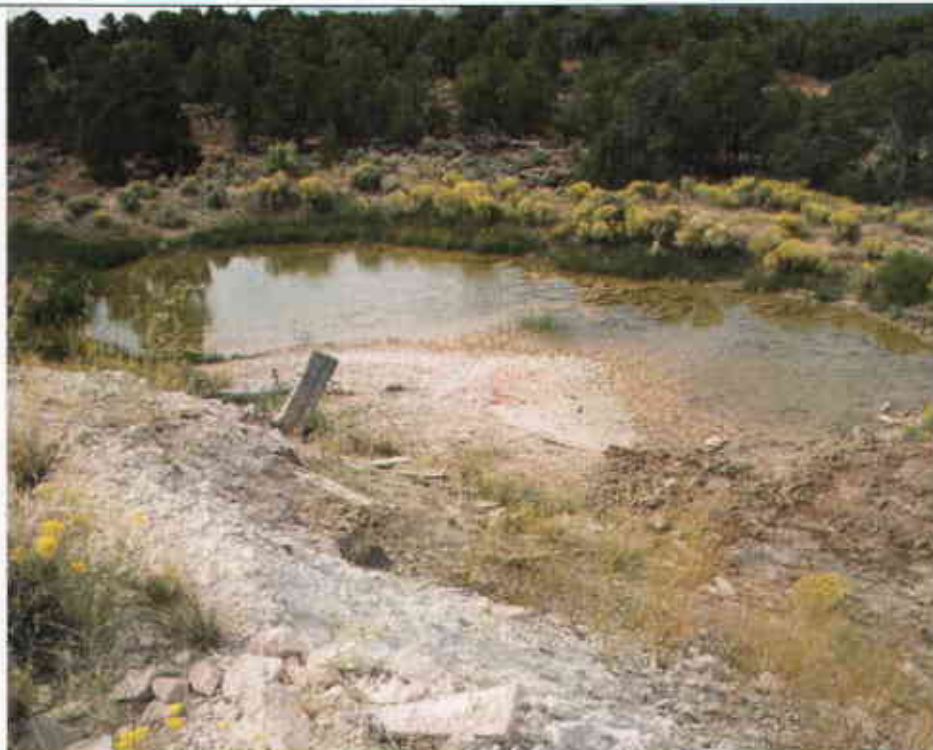
Photo 1:
Photograph
of temporary
sediment
pond at the
toe of the
Rim waste
rock area.

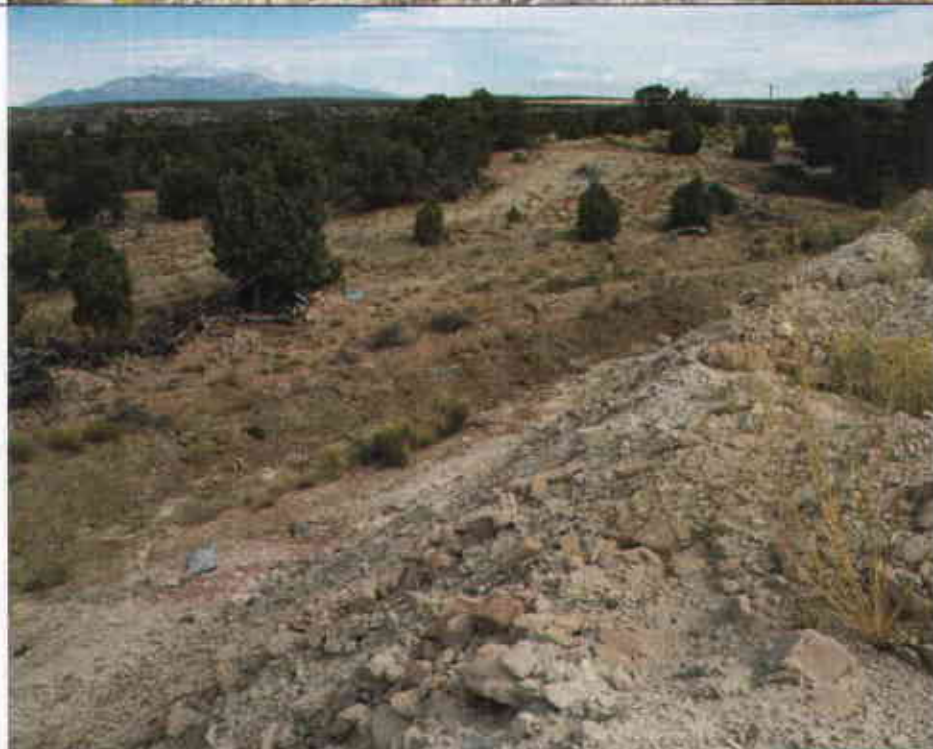
Photo 2:
Photograph
of ditch at toe
of waste rock
area. Ditch
leads to
temporary
sediment
pond.

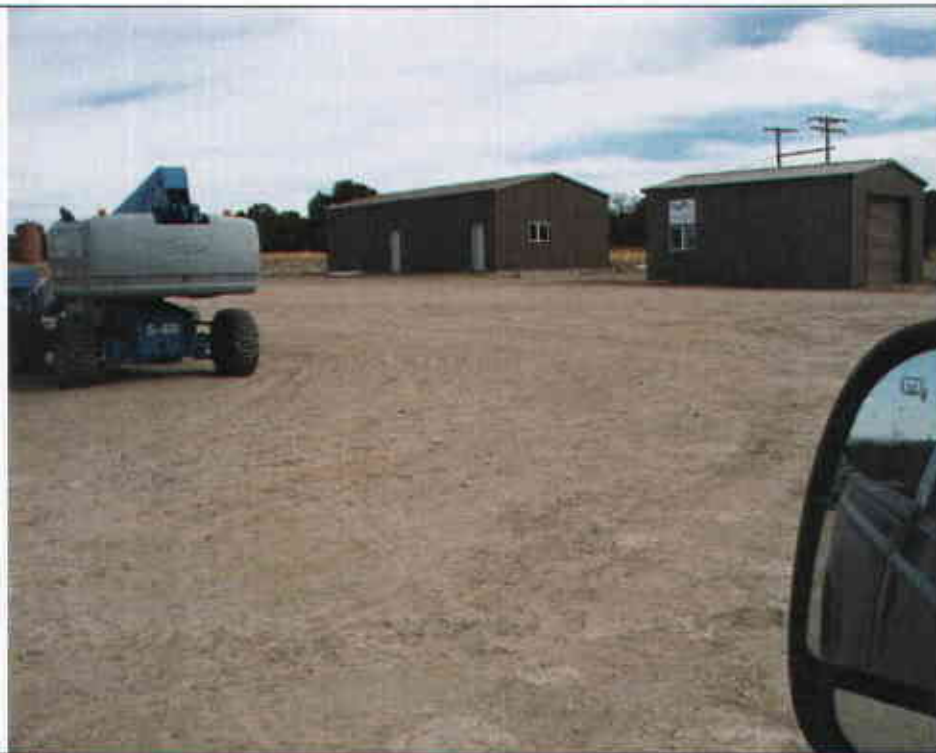
Photo 3:
Photo of two
newly
painted
buildings at
the Rim
Shaft.
Buildings are
on existing
foundations
and included
in bond
estimate.

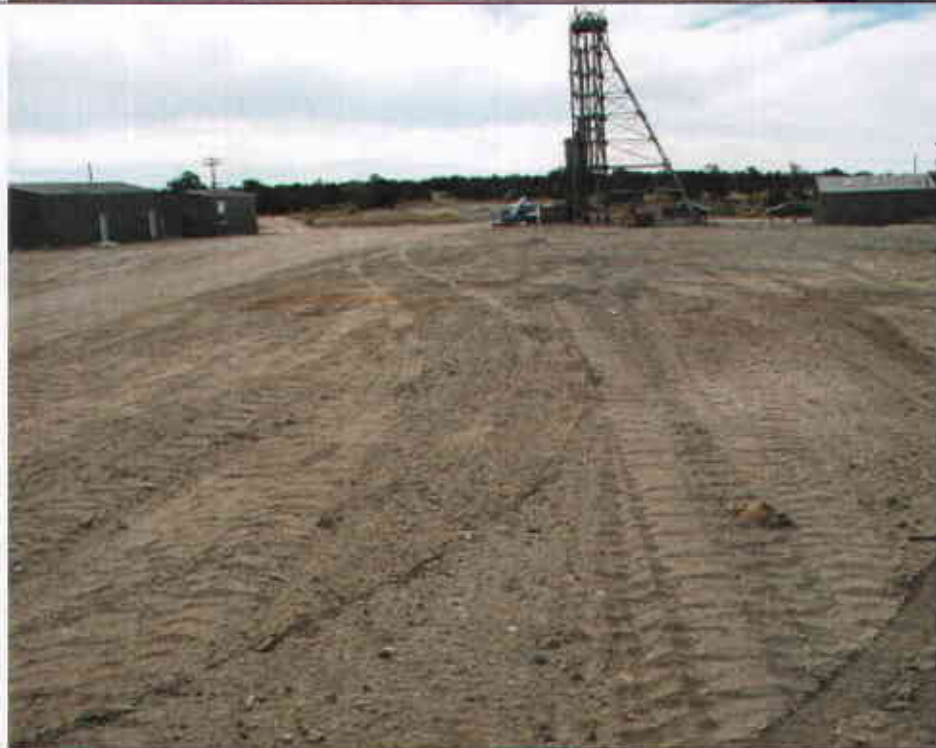
Photo 4:
Photo of the
two new
buildings at
the Rim
Shaft.

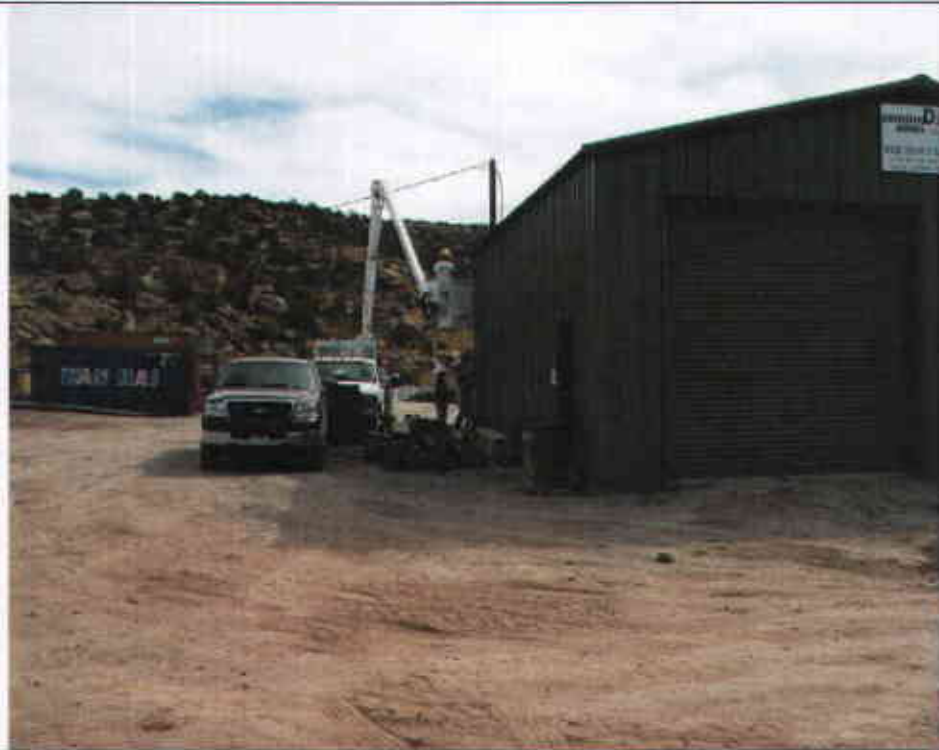
Photo 5:
Picture of
newly
painted
building at
the Humbug
Portal.

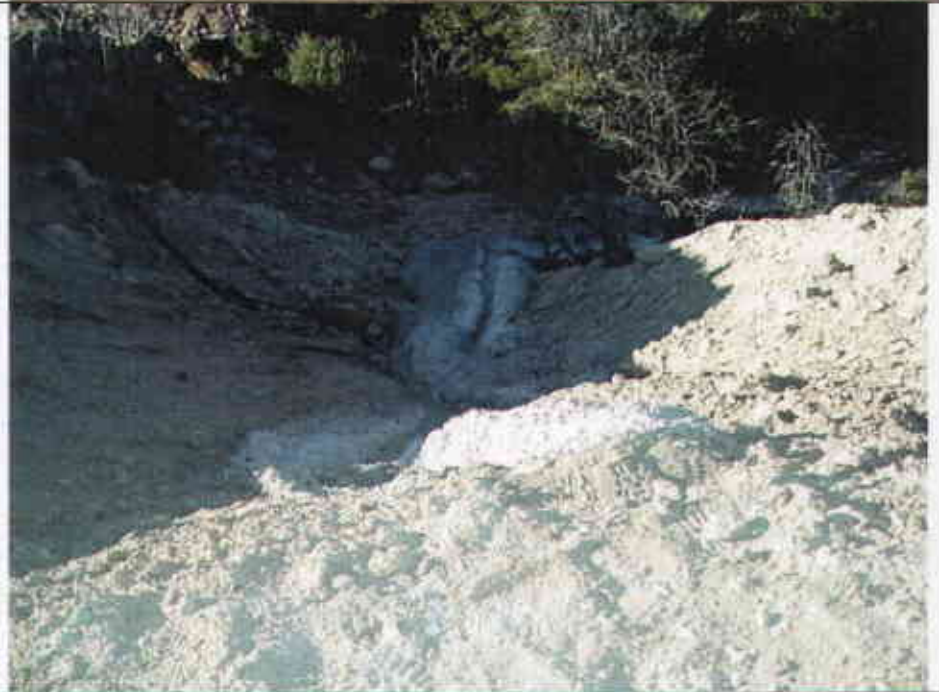
Photo 6:
Area where
concrete was
previously
poured.

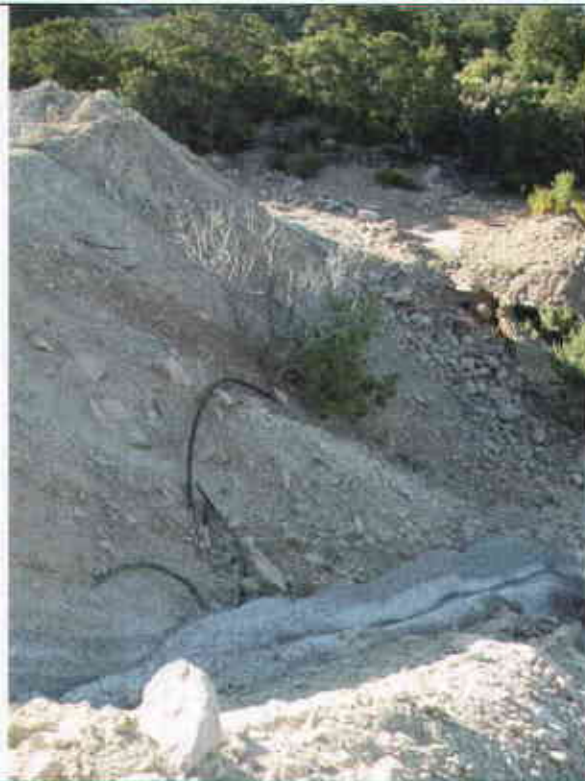
Photo 7:
Area where
concrete was
previously
poured.

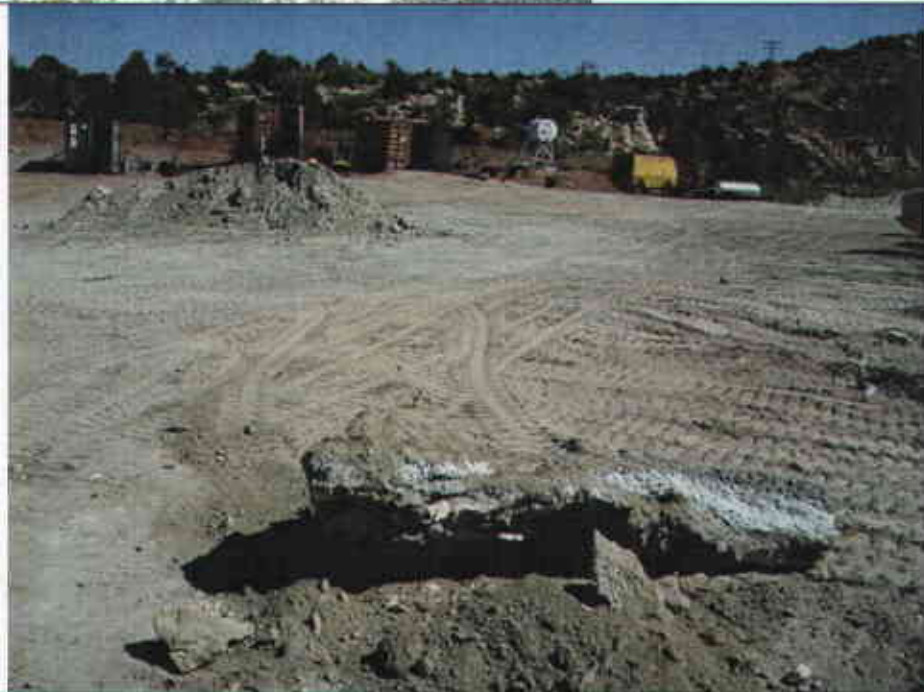
Photo 8:
Broken up
concrete
from waste
rock area.

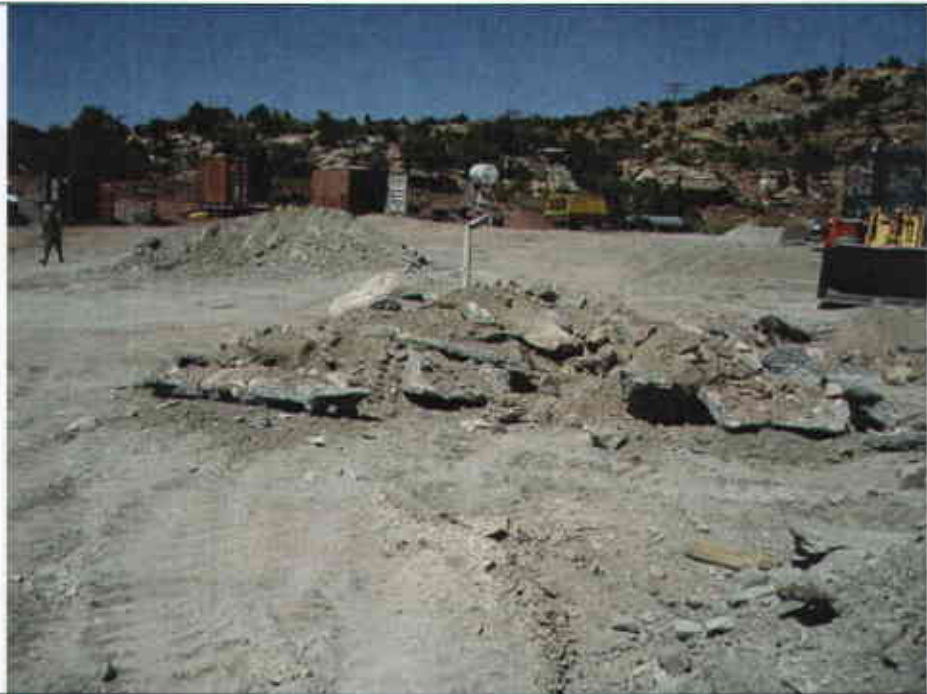
Photo 9:
Broken up
concrete
from waste
rock area.

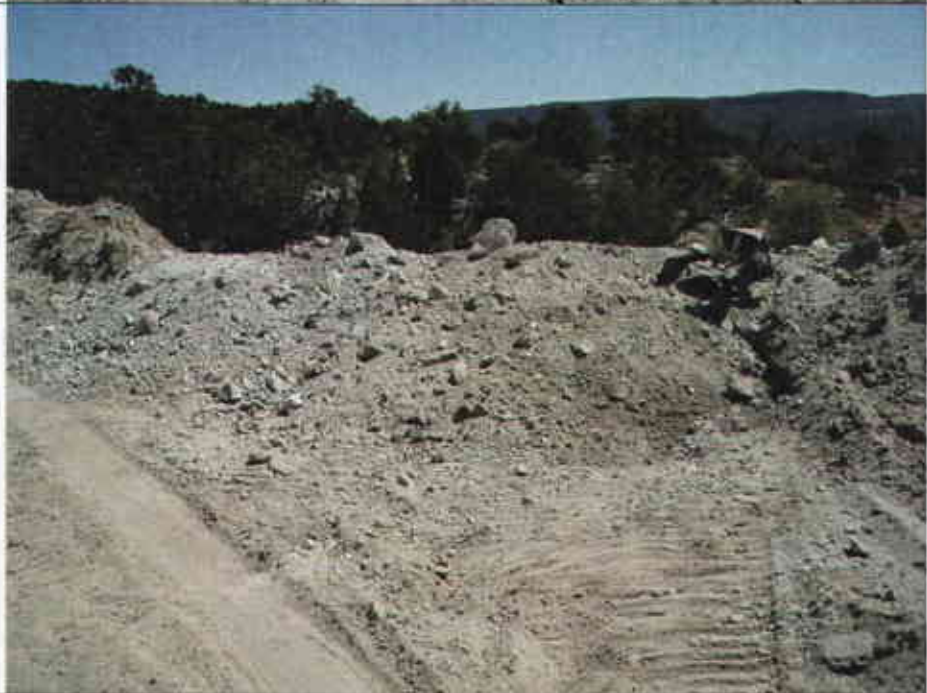
Photo 10:
Top of waste
rock area
where
concrete was
previously
poured.

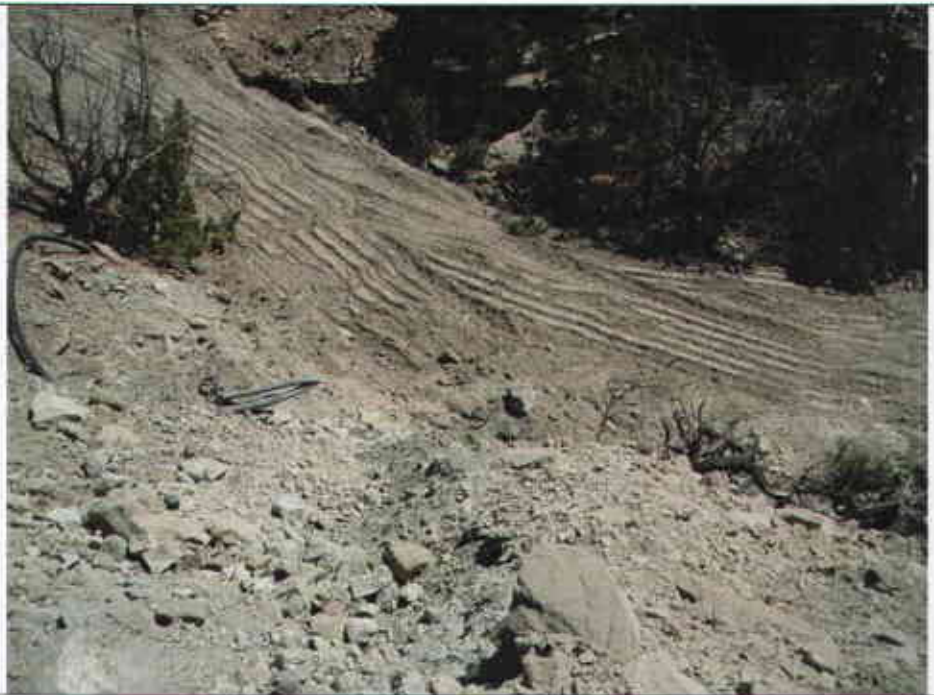
Photo 11:
Waste rock
area where
concrete was
previously
poured and
has been
removed.
